URGENT MEDICAL DEVICE CORRECTION**September 10, 2019****To:** Hospital/Surgeon Name**Affected Product:** ROSA Brain 3.0**Serial No.:** BRxxxxx

ROSA Brain 3.0

Medtech S.A - Zimmer Biomet - is initiating a medical device Field Safety Corrective Action for ROSA Brain 3.0 products. This notice informs you of the issue and the corrective actions Zimmer Biomet is taking.

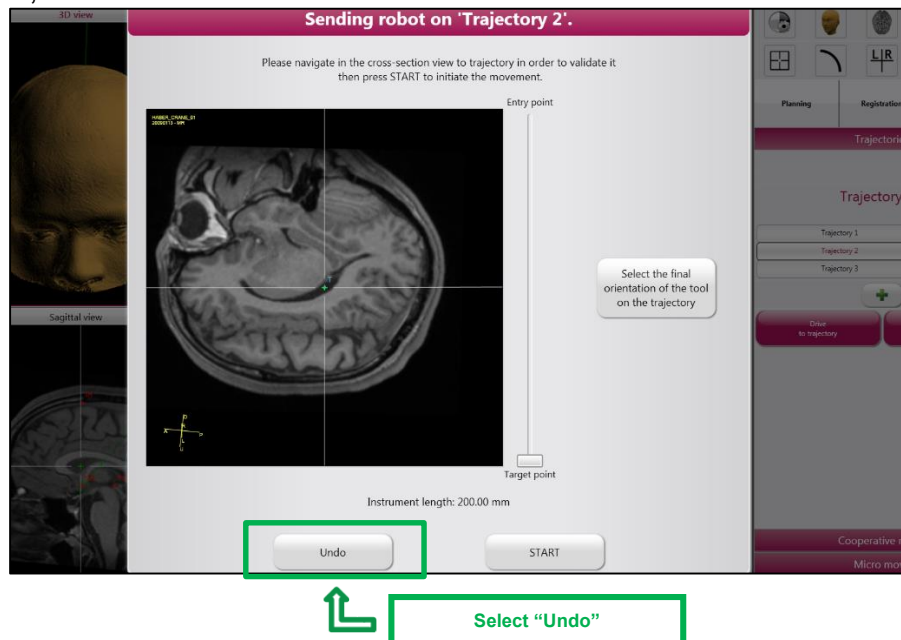
- In the next frame, select Undo
