URGENT MEDICAL DEVICE CORRECTION**September 10, 2019****To:** Hospital/Surgeon Name**Affected Product:** ROSA Brain 3.0**Serial No.:** BRxxxxx

ROSA Brain 3.0

Medtech S.A - Zimmer Biomet - is initiating a medical device Field Safety Corrective Action for ROSA Brain 3.0 products. This notice informs you of the issue and the corrective actions Zimmer Biomet is taking.

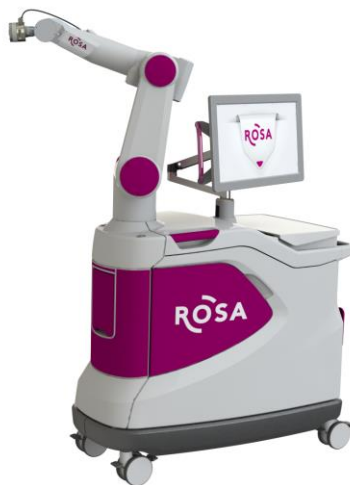
Zimmer Biomet is aware of events where the ROSA Brain 3.0 instrument holder was sent on a trajectory that is not within the intended target. The robot arm is intended to position the instrument holder on the selected trajectory so that rigid neurosurgical instruments such as drill bit, screwdriver, cannula, etc. - are inserted through the adaptor to perform the intended surgical procedure.

While the incorrect trajectory was detected in all reports received to date (e.g. the robot arm is at an unusual distance from the patient's head, or the instrument is not at the correct position), if it is not corrected, the associated device may be placed incorrectly (e.g. the anchor bolt). Failure of the device to move to the correct trajectory, if not identified by surgical staff, could result in serious injury or death.

1. Review this notification for awareness of the contents.
2. There are no specific patient monitoring instructions related to this field action that are recommended beyond your existing follow up schedule.
3. Complete the enclosed Certificate of Acknowledgement.
 - a. Return a digital copy to CorporateQuality.PostMarket@zimmerbiomet.com
 - b. Retain a copy of the Acknowledgement Form with your field action records in the event of a compliance audit of your documentation.
4. If you have further questions or concerns after reviewing this notice, please call Perry Twyford at 281-389-3236 between 9:00 am and 6:00pm EST, Monday through Friday. Alternatively, your questions may be emailed to CorporateQuality.PostMarket@zimmerbiomet.com.
